## Edge Protect Technical Information

Due to the way windshields are manufactured and mounted in vehicles, the amount of stress around the outer 50 mm perimeter is significantly greater than inside that area and will fracture 2.5 times easier than the rest of the windshield. Most replacements are from an Edge Crack, which occurs because the first 50 mm around the outer perimeter of windshields have 2 manufacturing stress areas.

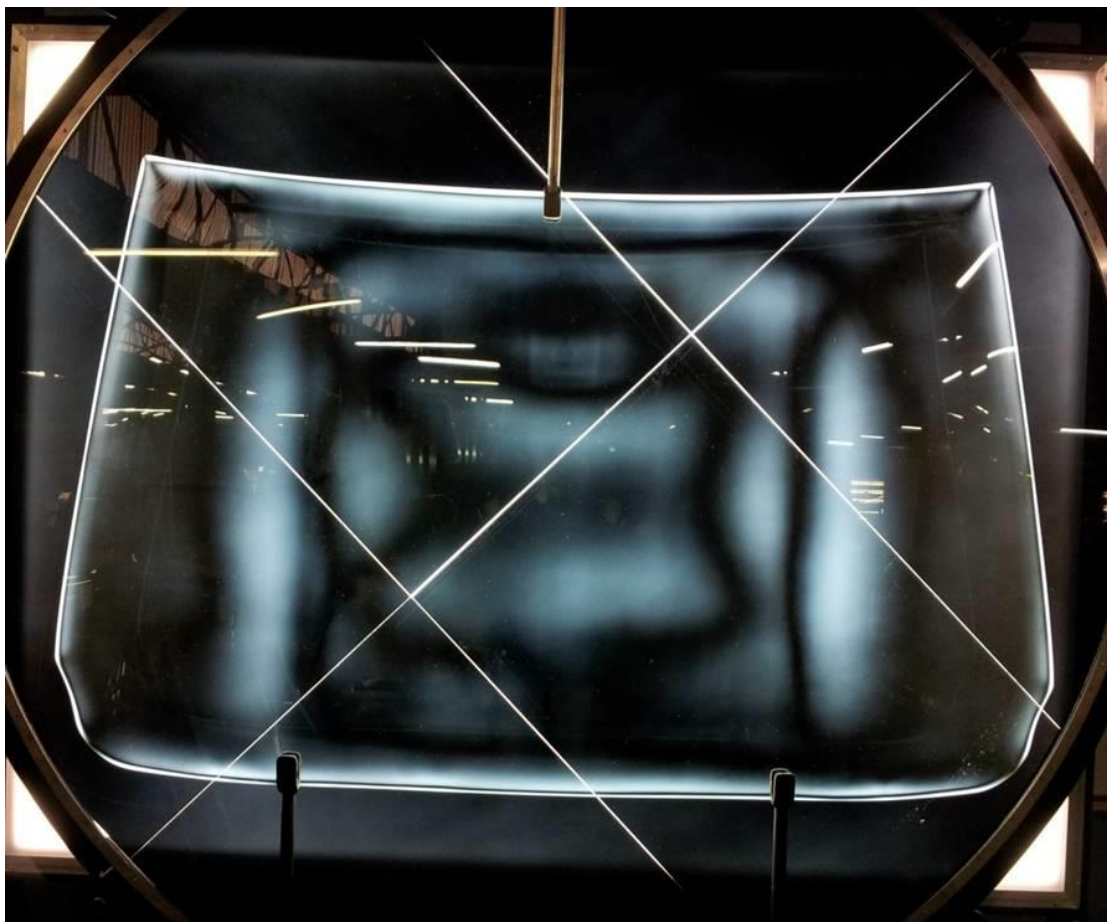
See Diagram

The first one is "residual stress" which is created during the moulding and annealing process. This tensile stress is created by rapid, differential rates of cooling to the perimeter of the windshield during the annealing process. The edge or perimeter of the windshield sits on a metal frame as it comes out of the oven into room temperature after being moulded. While the edge starts to cool the metal frame is still extremely hot, while the glass cools on the other side of the frame at another rate. These three temperature clashes at the 50 mm edge area, cause the cross linked molecules to split and is called Edge Compression. This has now become the weakest area of the windshield and will fracture 2.5 times easier than the rest of the windshield.

Unfortunately the compressive stresses are balanced by inboard tensile stresses. This tensile zone is the weakest area of a glass and breaks/cracks very easily when damaged. The tensile zone extends from, depending on the windscreen and the processing conditions, from approximately 3mm to approximately 50 mm from the edge. The first one is "residual stress" which is created during the moulding and annealing process. This tensile stress is created by rapid, differential rates of cooling to the perimeter of the windshield during the annealing process. The edge or perimeter of the windshield sits on a metal frame as it comes out of the oven into room temperature after being moulded. While the edge starts to cool the metal frame is still extremely hot, while the glass cools on the other side of the frame at another rate. These three temperature clashes at the 50 mm edge area, cause the cross linked molecules to split and is called Edge Compression. This has now become the weakest area of the windshield and will fracture 2.5 times easier than the rest of the windshield.
